Machinery Messages

Protection against thrust bearing failure in a steam turbine

by **Charlie Jackson**
Turbomachinery Consultant

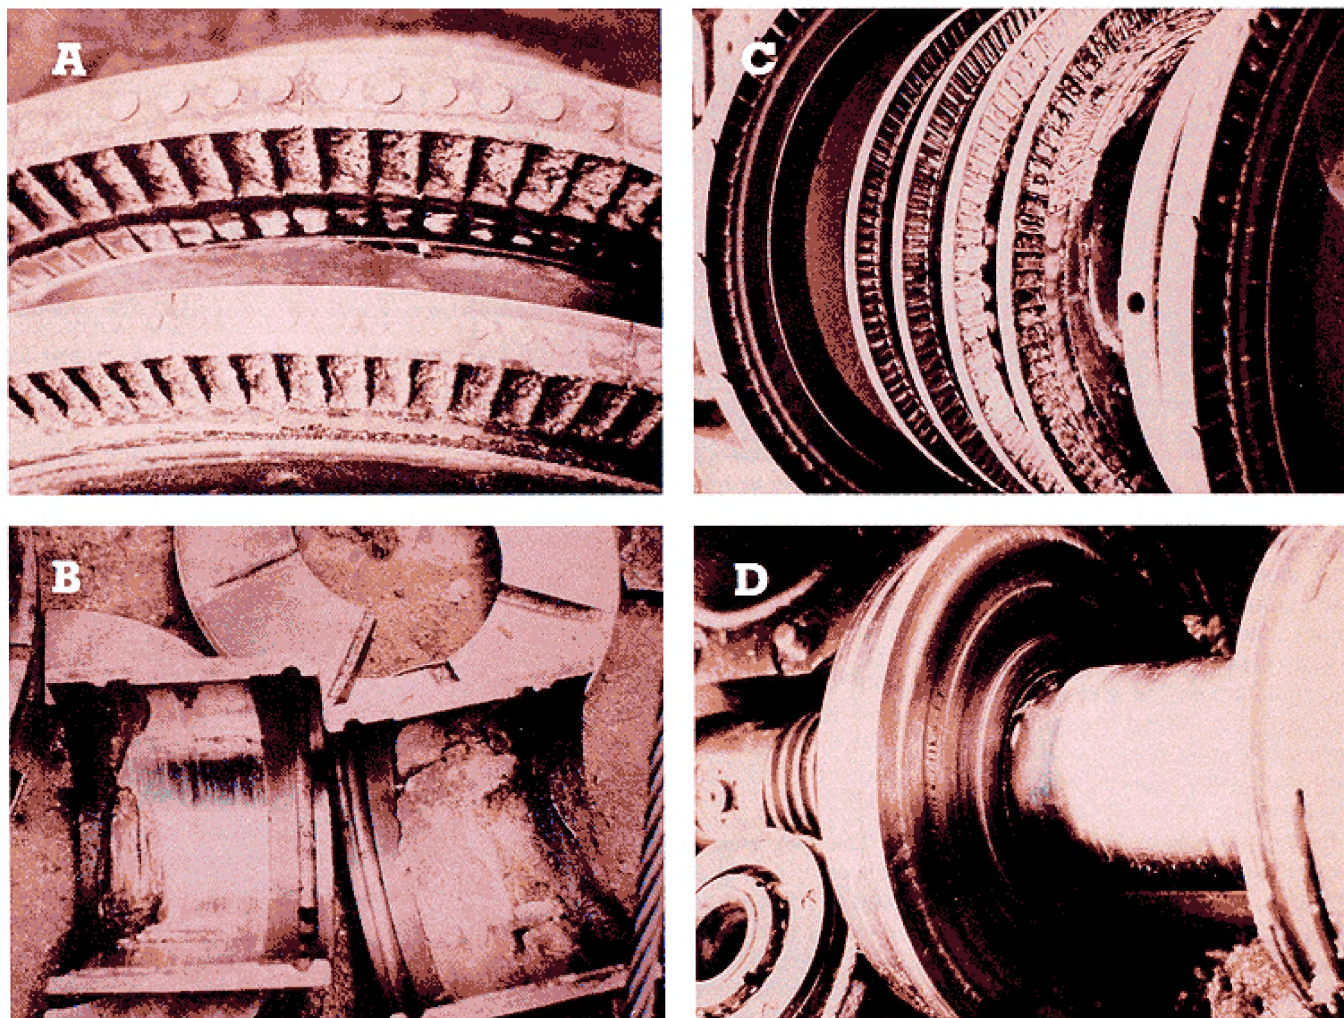
Figure 3

An 18,000 horsepower steam turbine in an ethylene plant was driving two centrifugal compressors at approximately 4,500 rpm. Dual thrust probes were mounted on the turbine but without automatic thrust travel shutdown limits. The thrust and radial bearing failure (Figure 3) was part of a sequence which started in the mid 1970s. As a result of this failure, the thrust axial movements were placed on automatic shutdown. The babbitt (white metal) thickness was 30 mils (762 μm). Alarm setpoints were set at **15 mils (381 μm) for Alert and 25 mils (635 μm) for Danger with automatic shutdown and a three-second integrated time delay.**

These exchangers leaked, contaminating the steam quality with sodium chloride. The ten stage turbine developed salting problems when brine and treated water contaminated the boiler feedwater due to leaks in the internal exchangers of a flash evaporator. The salt, primarily sodium chloride (table salt), settled out selectively on the fifth and sixth stage blading, obstructing the flow to a 40 percent, or less, flow passage area. The dew point was 500-525°F (260-274°C).

This failure melted the thrust bearings. The rotor thrust face had "severe" heat check tears in the active face. The radial bearing overheated and melted the babbitt [high tin babbitt melts at 415°F (213°C)]. The melted babbitt flowed down the drain oil pipe and solidified, blocking the oil flow. It is fortunate the oil flow was blocked, otherwise plant operators would have restarted the steam turbine if oil flow could have been established.

(A) Closeup of the fifth and sixth stage blading showing salt buildup which obstructed flow to 40 percent.

(B) Melted journal bearings at the thrust end. The melted babbitt flowed down the drain oil pipe and resolidified.

(C) Salt formation on the fifth and sixth rows of a ten stage 18,000 HP steam turbine.

(D) Damaged active thrust collar. Note: heat tears in the metal and blue color on the journal.

The rotor was cleaned. The contamination to the boiler feedwater was corrected through exchanger repairs. Steam conductivity meters and alarms were installed to monitor steam conditions.

The blades were straightened in the turbine builder's repair shop. The turbine was returned to service within one week, but the failure cost over one million dollars in 1977 dollars. Normally,

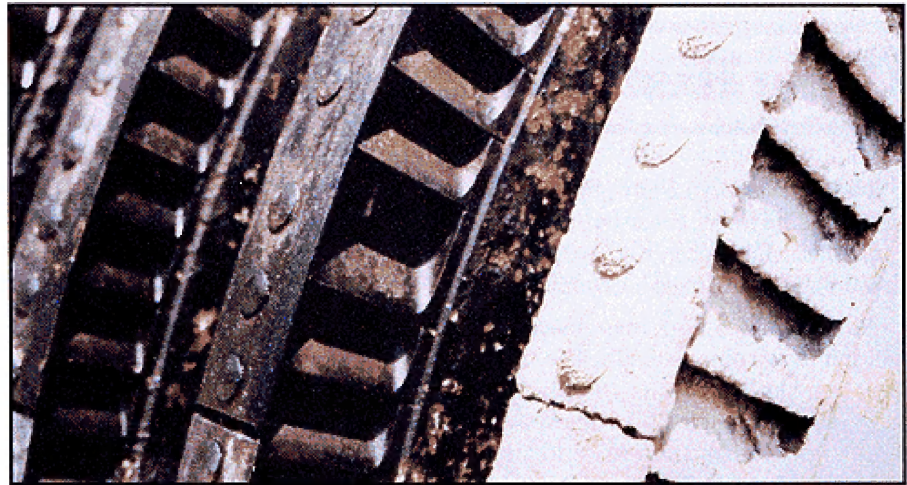
A 1989 incident is a good example of poor conditions leading to back pressure turbine salting and overloading of the thrust bearing on the steam turbine. A turbine received desuperheated steam at 650° to 750° (343° to 399°C), not the traditional 600 psi (4,136,880 N/m²) steam at 700°F (371°C). Usually, the turbine received steam at too low a superheat, between 600° and 650°F (316° to 343°C), so the maximum amount of condensation is returned to the unit's reactor steam generating system. Mineralized condensate from the deaerator and other units also added to the problem.

Figure 5
Salt deposits on last row of Rateau blading.

Steam Turbine Unit 2 was opened to install an improved radial bearing and to repair casing leaks. The last row of 5 Rateau blading was heavily fouled (Figure 5). The thrust bearing shows the overloaded "darkened" areas, confirming that 75% arc and 75% radius remains an accurate placement for the thermocouple. (However, never embed thermocouples into the babbitt!)

The rotor was inspected through the tapped hole for the Sentinel valve, which fortunately looks directly at the last stage bucket (on center pitch). Blade conditions were recorded with a lens/light through the plug for the Sentinel valve. Two selected hydroblast nozzles with reduced water pressure were used to clean the buckets through this opening without disassembling the steam turbine. The area was washed to very good condition while spinning the 10,000 horsepower steam turbine rotor at 70 rpm.
